HEALTH MONITORING OF PRECAST BRIDGE DECK PANELS  
WITH GLASS FIBER REINFORCED POLYMER BARS

A dissertation submitted to the faculty of  
The University of Utah  
in partial fulfillment of the requirements for the degree of

Department of Civil and Environmental Engineering

The University of Utah

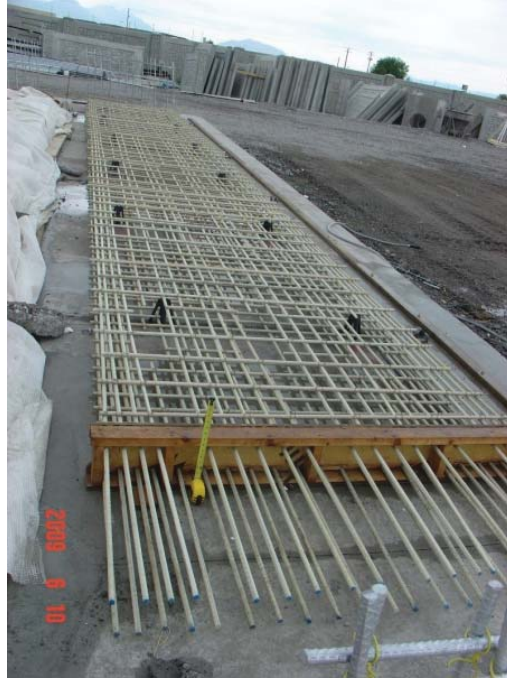
Figure 3.3. GFRP bar layout with bars extended for the closure pour

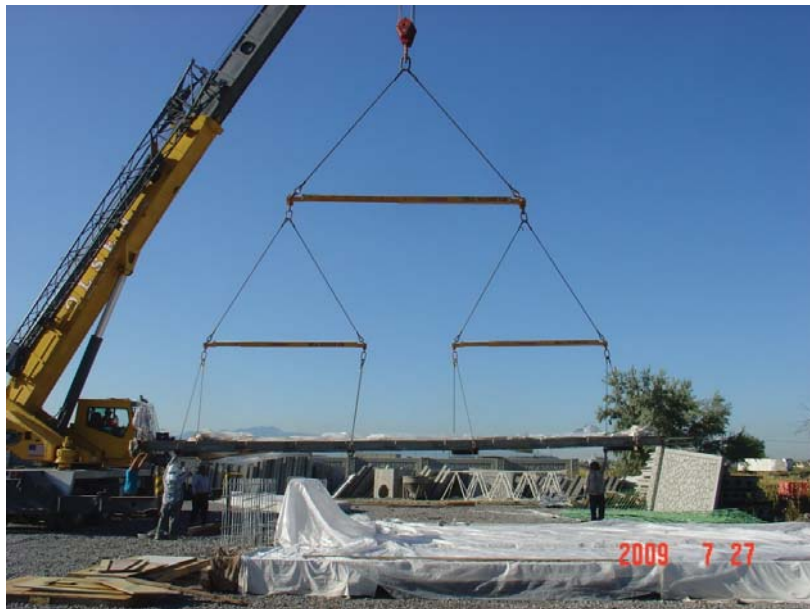
Figure 3.7. First lift out of the forms at the casting yard

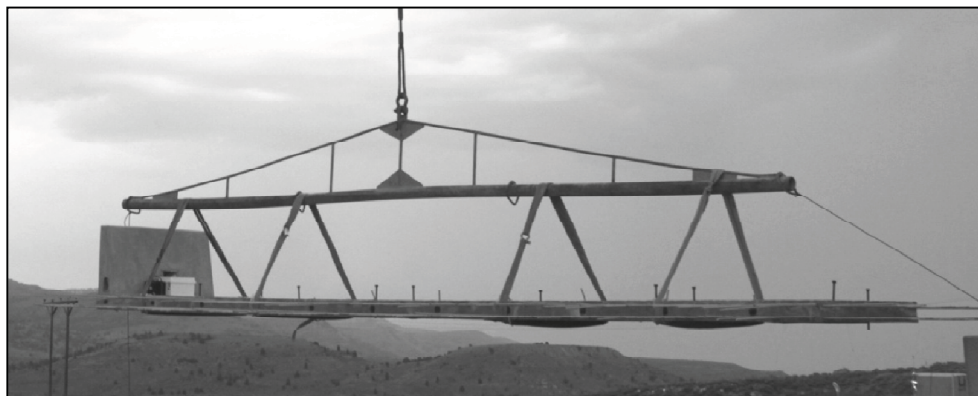
Figure 3.8. Third and last lift at the bridge including parapet

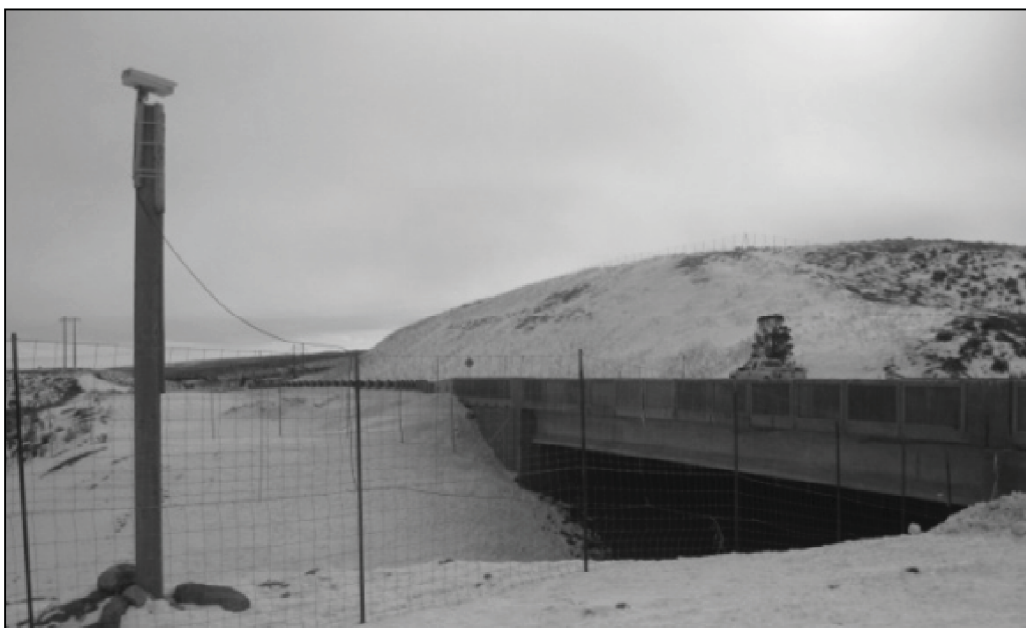
Figure 5.3. Still camera used for visual record of trucks causing large accelerations

A still camera was mounted on a 15 ft post located approximately 30 ft north of the west abutment as shown in Figure 5.3. The purpose of the camera was to obtain a visual

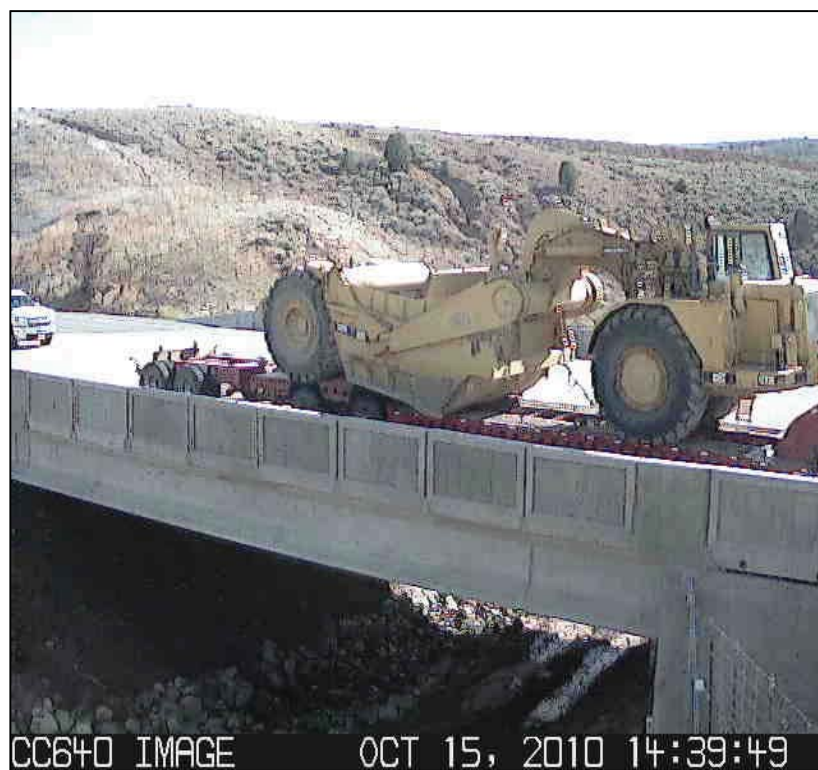
Figure 5.11. Picture of truck for acceleration of Figure 5.10
